Dynamic Tests Of Short Sections Of Corrugated Metal Beam
Guardrail

January 1969

State of California
Department of Public Works
Division of Highways
Materials and Research Department

DYNAMIC TESTS OF SHORT SECTIONS OF
CORRUGATED METAL BEAM GUARDRAIL

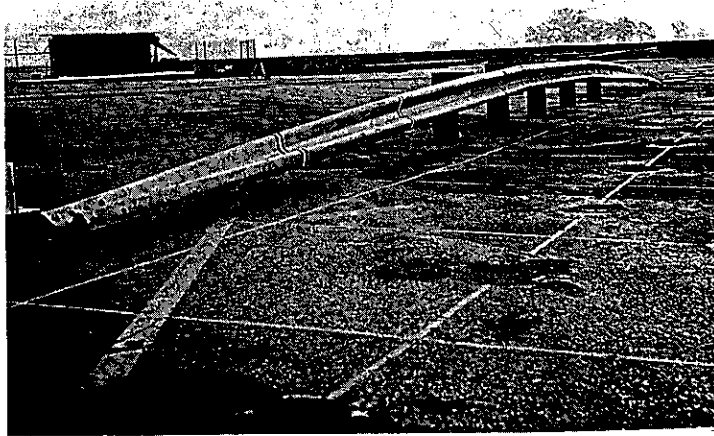
Figure 1

The first guardrail end anchorage design tested was developed by the Texas Highway Department and is referred to as the "Texas Twist". The installation for Test 133 consisted of a 62.5-ft section of corrugated metal guardrail beam. The 25-ft long center portion of California standard guardrail was anchored at each end with 18-ft 9-in. of the beam section twisted 90 deg axially, bent down and bolted to fabricated steel posts cast in 18-in. diameter by 5-ft deep concrete cylindrical footings. The sloped end anchorage beam had no intermediate supports (Figure 1).

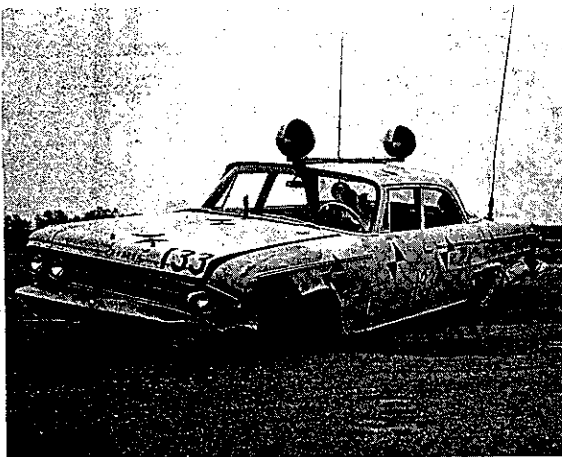
Figure 2

considered good with the vehicle sustaining moderate front end damage (Figure 2). The permanent deflection of the guardrail beam was 2.8-ft horizontal (back) and 6-in. vertical (up).

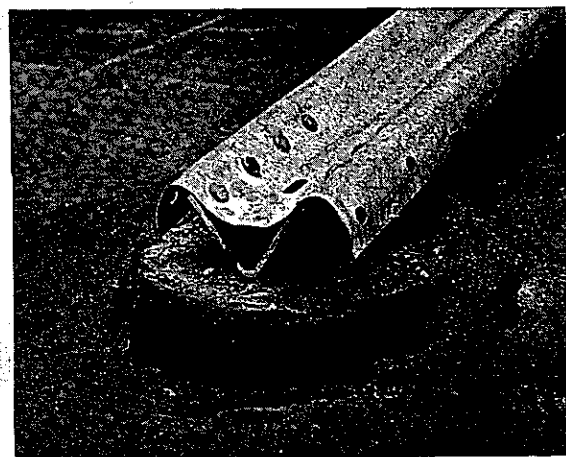
Figure 3

All beam sections were damaged. A 3/8-in. wide crack was opened in the downstream concrete footing and the upstream footing was displaced approximately 2-1/2-in. toward impact (Figure 3).

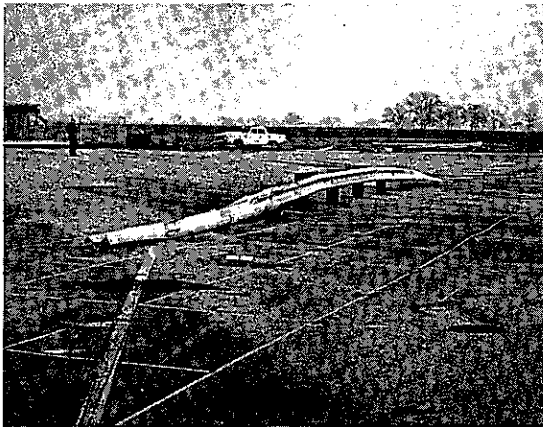
Figure 4

The end section of beam was flattened and one post and block-out block shattered (Figure 4).

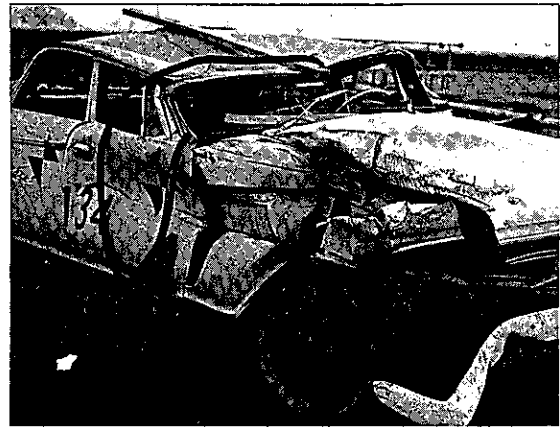
Figure 5

The vehicle sustained major front, side, and top damage and was considered a total loss (Figure 5).

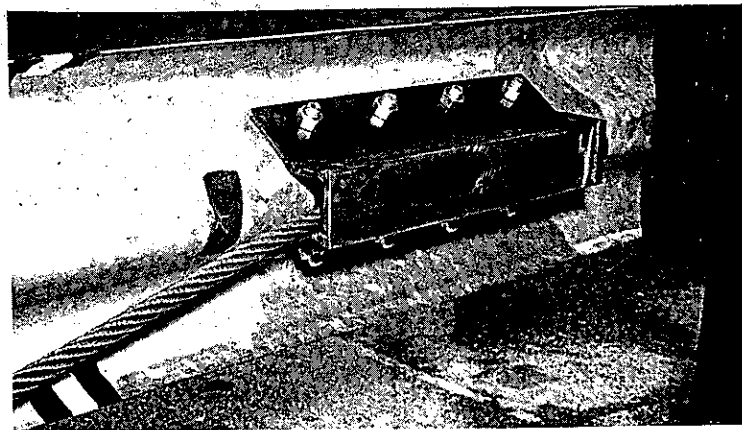
Figure 6

The test installation consisted of a 50-ft length of corrugated metal beam guardrail constructed as a parabolic flare. In order to reduce the lever arm effect of the axial force acting about the posts, block-out blocks were not installed on the end posts and 4-in. thick blocks were used on the posts next to the end. Each end of the beam was secured with a 3/4-in. steel cable (breaking strength 21.4 tons) attached to the beam with a special fitting between the first and second posts (Figure 6 and Exhibit 1).

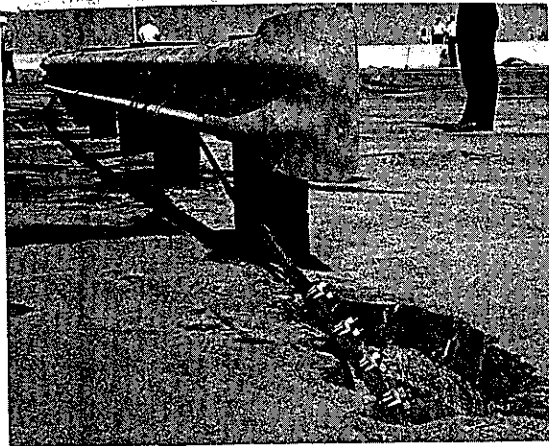
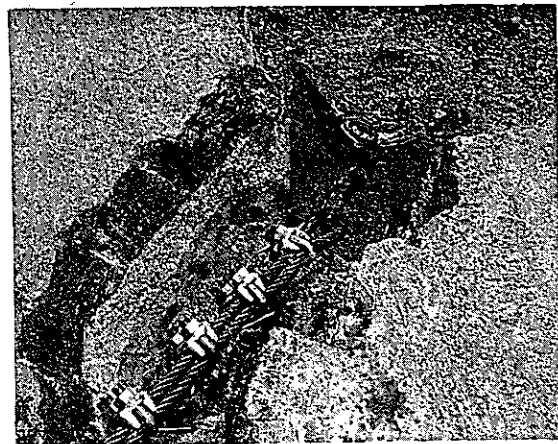
The other end of each cable was clamped to a 1-1/4-in. eye bolt cast in an 18-in. dia by 5-ft deep cylindrical concrete footing (Figures 7 and 8).

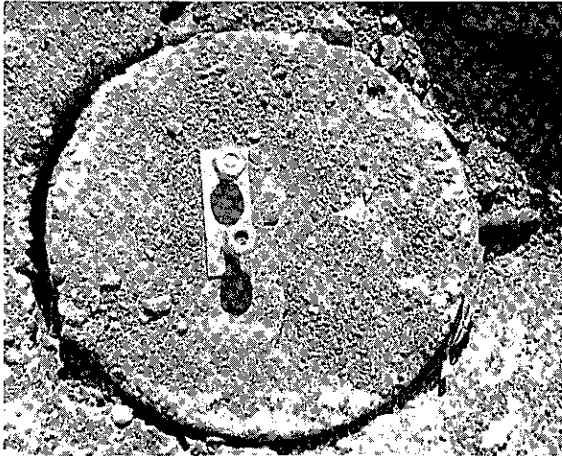
Figure 9

All beam sections were damaged and both anchors were displaced approximately 5/8 in. toward impact (Figure 9). The test vehicle sustained moderate front end damage (Figure 10).

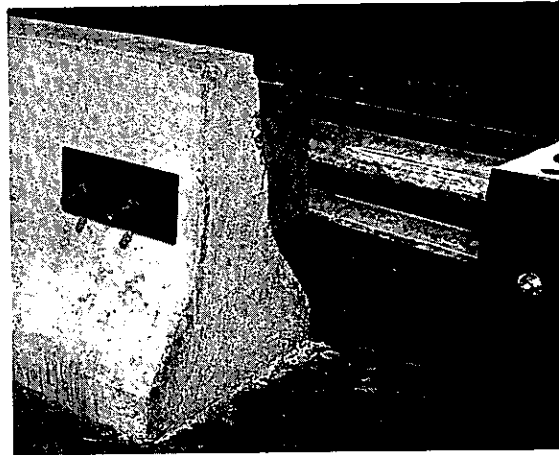
Figure 12

the first 12 ft from the bridge rail end so the remainder of the barrier could be placed on a straight line with a 4-ft end offset from a projection of the bridge rail line (Figure 11). The downstream end of the guardrail beam was secured to a nonreinforced concrete simulated bridge rail with two 1-in. dia high strength bolts through 1-1/8-in. dia holes bored through the concrete. An 8- by 12- by 18-in. wood block was placed between the beam and the concrete (Figure 12).

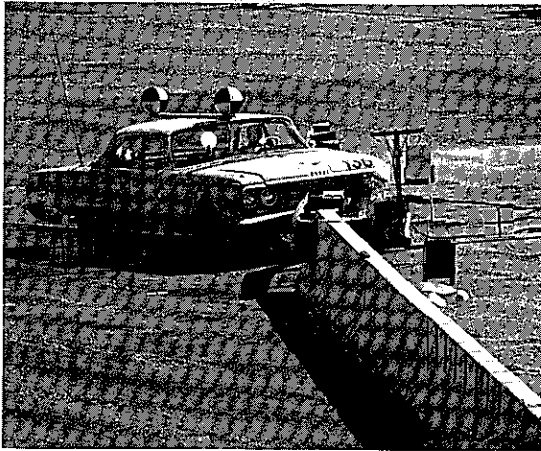
The test vehicle impacted the guardrail at 60 mph/33 deg 18 ft upstream of the end of the simulated bridge rail, pocketing the beam severely (see Figure 13 and Plate D). As the vehicle was being redirected, the nonreinforced concrete bridge rail failed through the connection holes, allowing the beam to pull free and permitting the vehicle to penetrate the barrier. As the vehicle progressed through impact, the right front wheel struck the end of the concrete rail throwing the vehicle into a violent roll-over. The vehicle came to rest 45 ft beyond initial impact in an upright position. Two sections of beam were damaged, three timber posts broken off, and four block-out blocks shattered. The vehicle sustained major front, side, and top damage and was considered a total loss (Figure 14).

Analysis of the data film indicated that even if the concrete bridge rail connection had not failed, beam deflection and pocketing had already occurred to such an

extent that the vehicle would not have been redirected sufficiently to avoid an end-on collision into the concrete rail.

To correct the deficiencies noted in the previous Test 136, several modifications were made for the Test 137 installation. To more accurately depict a typical installation, a simulated California Standard Type 1 bridge rail end post was constructed of reinforced concrete in accordance with design details typical of current operational installations. A 50-ft section of metal beam guardrail was constructed on a straight line so that the upstream end was offset 4-ft from the projected bridge rail line (Figure 15).

To minimize the pocketing noted in Test 136 and to provide a smooth transition from the semi-flexible guardrail to the rigid bridge rail, the guardrail post spacing near the bridge rail was decreased from 6-ft 3-in. to 3-ft 1-1/2-in. and the size of the three wood posts immediately adjacent to the bridge rail was increased from 8- by 8-in. to 10- by 10-in. posts. The upstream end of the guardrail was anchored with the same cable anchorage installation used in Test 136 (see Exhibits 1 and 2).

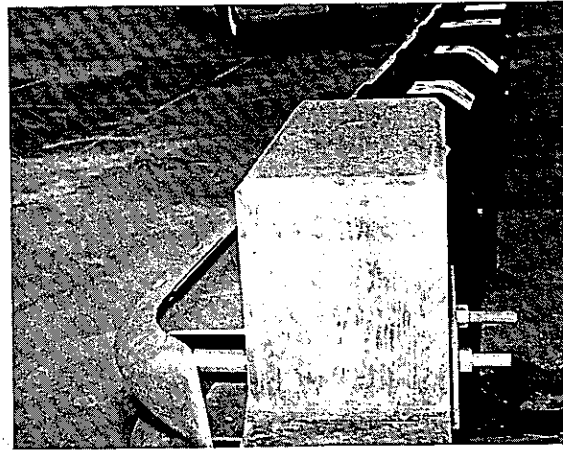
The block between the guardrail beam and the concrete end post was constructed of 1/4-in. steel plate rather than wood (see Figure 16 and Exhibit 2) to add rigidity to the system and prevent crushing of the block as occurred in the previous test.

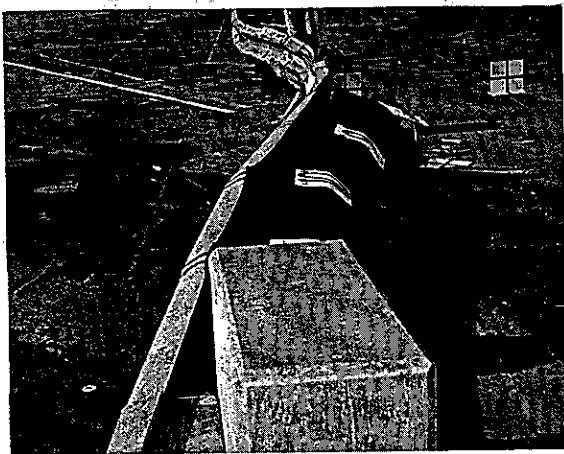
Figure 17

The guardrail beam sustained a permanent deflection of 2.1 ft (Figure 17).

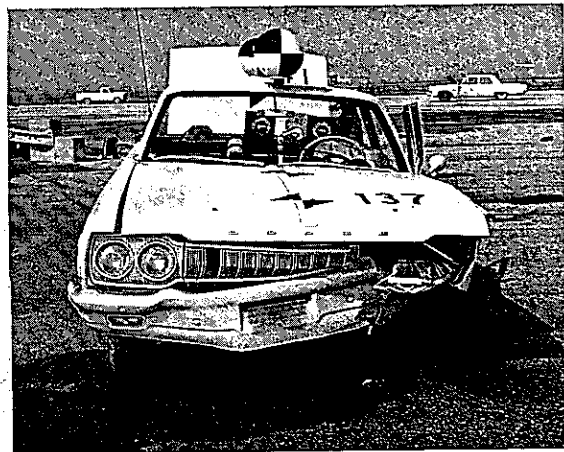
Figure 18

Although vehicle dynamics in this high speed oblique angle collision were considered good through impact, the left front wheel was torn off and the vehicle sustained major front end and undercarriage damage. The vehicle was considered a total loss (Figure 18).

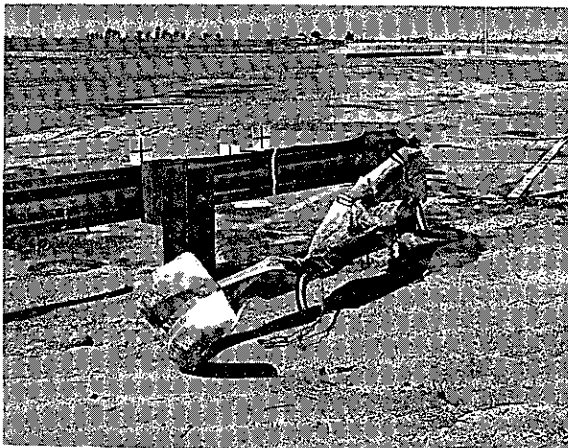
Figure 19

spearing" into the end of a flared guardrail section are not great, the upstream cable anchorage system does present a potential hazard. In Test 138 (installation identical to Test 137) the vehicle impacted the guardrail at 61 mph/25 deg into the end terminal section, upstream of the cable-to-beam connection. The beam bent, the left front wheel rode up and over the cable anchor eye-bolt and the vehicle, straddling the cable, impacted post No. 1. The cable failed in tension as the vehicle, pushing the beam ahead of it, penetrated the barrier (see Plate F and Figure 19).

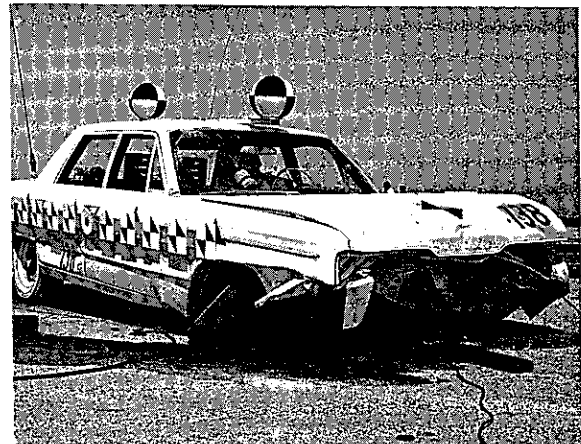
Figure 20

The vehicle sustained major front end damage with both front wheels smashed back under the engine compartment and was considered a total loss (Figure 20).
